Title: ANKARA TEMPLE (MONUMENTUM ANCYRANUM) / RESTORATION FOR TEMPLE OF AUGUSTUS AND ROME

Article Type: Case Study

ANKARA TEMPLE (MONUMENTUM ANCYRANUM) / RESTORATION FOR TEMPLE OF AUGUSTUS AND ROME

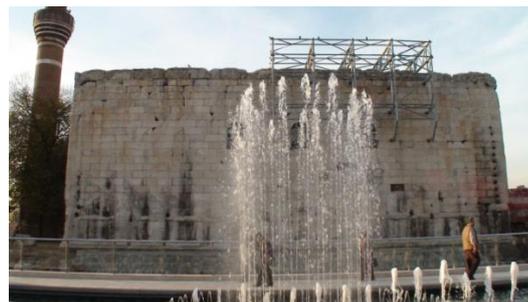
Fig 7. Deteriorations (External Walls)

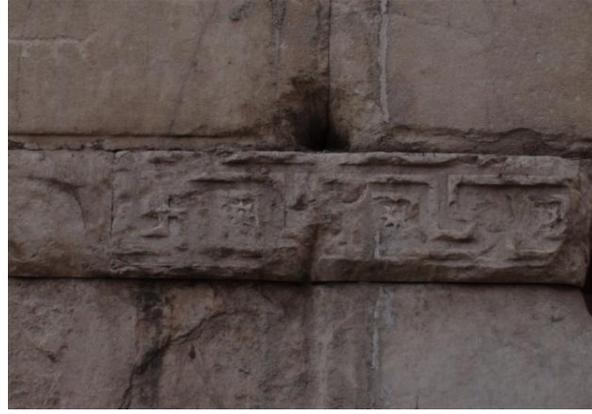
Fig 9. Deteriorations and Wrecks on the northern side walls

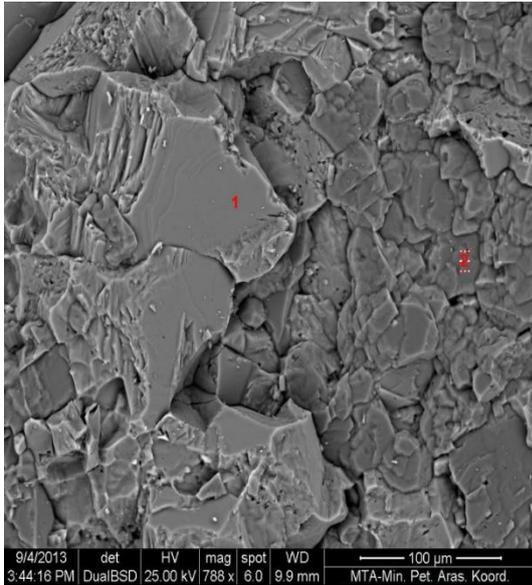
Fig 11. SEM Analysis (1,2) photograph

The photographs of scanning electron microscope SEM were taken with the scale 1 cm for 2 μm . It is taken with x300.000 and more zooming (Figure 11). The technique is used for taking high definition image with a focused beam of electrons. By the help of that technique, morphological, elemental and structural information can be gathered from low focusing to high focusing. Under high vacuum conditions, secondary electron (SE), back-scattered electrons (BSE) or mixed (SE+BSE) signal visions are gathered and photographed.

In the regions which include that structure, the particles are mostly arranged homogeneous, the shapes of them are cornered and fractured and the dimensions are in micrometers. The distances between these particles are seen to be narrowed. The dimensions are around 0.35-0.91 μm . In addition, spherical and closed spacing particles are seen along with geometrical shaped particles.

Another property which is seen in the SEM photographs is that the particles which have different sizes and shapes, have similar color tones. Although some particles are dark grey in color, in some regions light grey and white particles are also seen. That situation is obvious in all successive analysis. That image which is seen in the SEM photographs is a typical

crystalline structural shape which is also defined in literature. A homogenous structure is observed, the particles are observed to be in a tight form, large cavities and large particles are not observed.

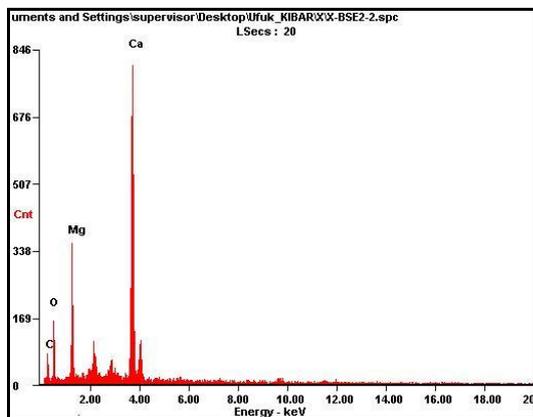
Fig 12 EDS Analysis Graphic

EDS analysis were applied by focusing on a point of 2 μm and it is applied by searching an area of (50 μm x 50 μm). That procedure is applied in a depth of 2.5 μm . In that analysis, the pure structure of the experiment sample is observed. In Table 3 and Table 4, atomic percentages which were obtained from EDS analysis are given.

Table 3 EDS atomic percentages

Elements	Atomic Percentage
C	29.86
O	40.37
Mg	12.80
Ca	16.96
Total	100.00

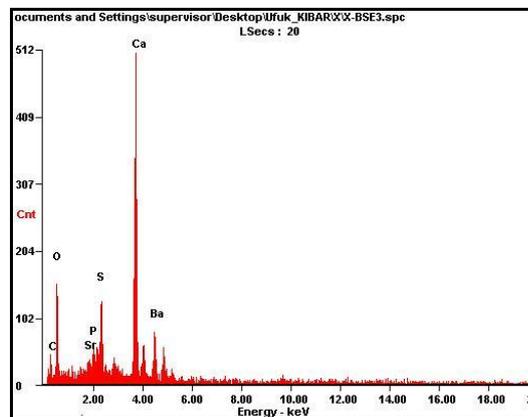
Fig 13 EDS Analysis Graphic

Table 4 EDS and atomic percentages

Elements	Atomic Percentage
C	24.47
O	52.27
Sr	0.67
P	1.73
S	4.08
Ca	14.00
Ba	2.79
Total	100.00

Moreover, EDS analysis indicate that various dissolutions were not formed, thus mainly a pure structure is observed during the analysis.

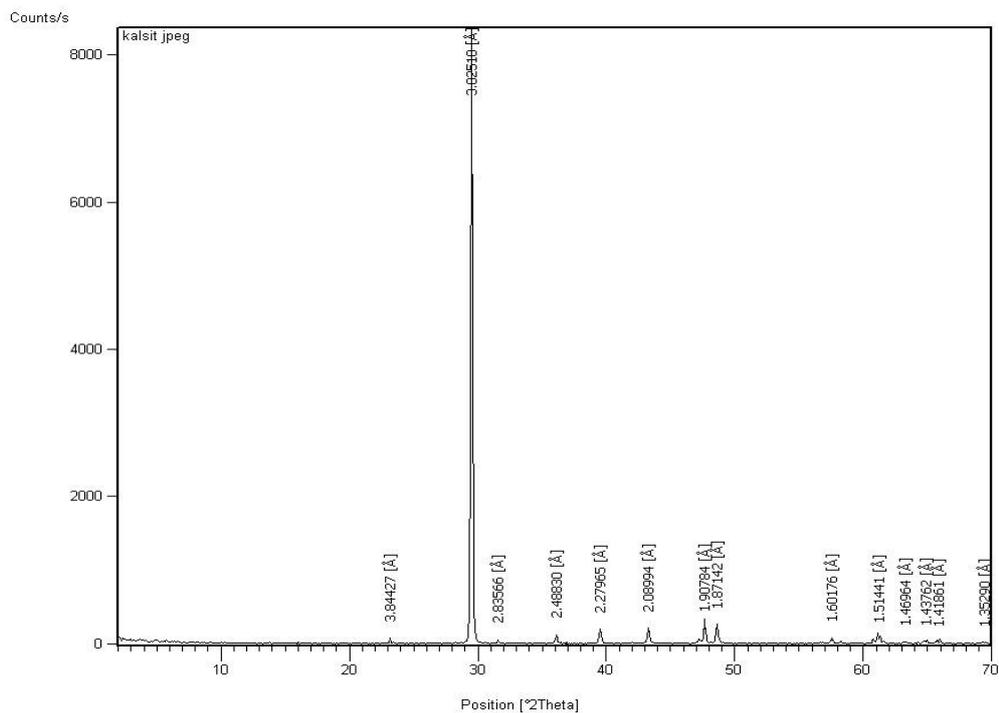
Fig 14.XRD Analysis Graphic

According to the results of XRD analysis in the Figure 14, the exterior and interior of main body of Naos are composed of calcite mineral.

While defining the microstructure of the experiment sample and while examining the crystal structure, X-ray analysis provided important findings. In the process, applying sintering with heat, the experiment samples are monitored from the nucleation phase to the last crystallization phase for crystallization duration and structural changes with XRD. These analysis have lots of benefits for observing different crystalline structures and for defining the appropriate heating conditions as well. Because of the same reason, the similarity between peak points indicates that the structure, which constitutes the sample, is in a pure phase, meaning that it is mainly composed of calcite mineral.

Turkish Republic Ministry of Energy and Natural Resources, MTA Mineralogy and Petrography Analysis Laboratory Unit has made Scanning Electron Microscope (SEM) and EDS (Figure 11,12,13), X-ray Diffraction (XRD) analysis (Figure 14) . With respect to the analysis, the main component of the temple is determined to be stone with calcite mineral. According to that determination, the materials and chemicals which will be used in the restoration process, have to have calcite mineral origins or they have to be compatible with calcite mineral.
