LIMESTONE IN ISLAMIC RELIGIOUS ARCHITECTURE: İSTANBUL AND TURKISH THRACE

Keywords: limestone; Islamic architecture;
paleontology; limestone quarries; Thrace
Basin; weathering; stone conservation

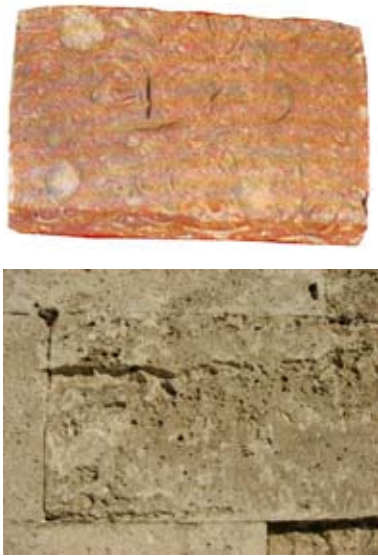
Figure 4. *Maetra Sarmatimactra* from Pınarhisar quarries on left (Küçükaya 2004) and fossil limestone used on the wall of Sultanahmet Mosque in İstanbul.

buildings either contained within layers of brick or plastered over. Later on the use of cut limestone became more usual, first in conjunction with brick and later on its own. Immediately after the conquest of Constantinople there seems to have been a reversion to brick and stone due to a shortage of cut limestone (Petersen, 1995). However, from the beginning of the sixteenth century onwards most important buildings were faced in cut limestone, although subsidiary structures continued to use brick and stone. In spite of metamorphic rocks and igneous rocks have traditionally been used as building material in Anatolia. As sedimentary rock the limestone had been used as the main building material during the periods of Roman, Byzantine and Ottoman in İstanbul and Thrace Basin (Figure 4) (Pehlivanoğlu, 2000).

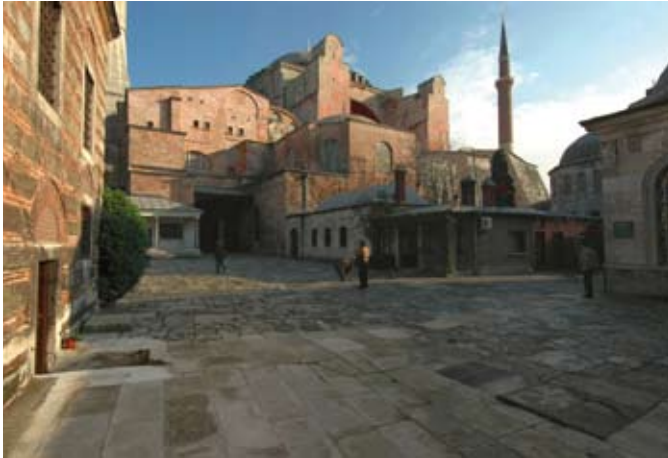
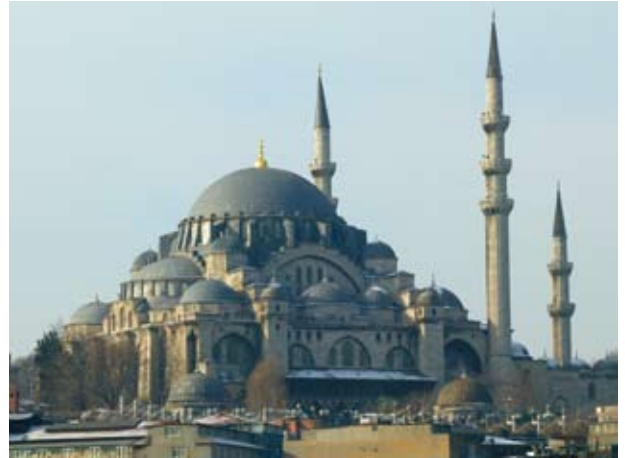
Figure 6. Hagia Sophia a former Orthodox basilica constructed between 537 (left) and the Mosque of Süleyman the Magnificent from İstanbul were constructed from limestone blocks (finished in 1558).

the Byzantium and Ottoman Empire Era for buildings in İstanbul such as Hagia Sophia (**Figure 6**), the Mosque of Süleyman the Magnificent (**Figure 6**) and the Walls of Constantinople surrounding the old city of İstanbul (**Figure 7-8**).

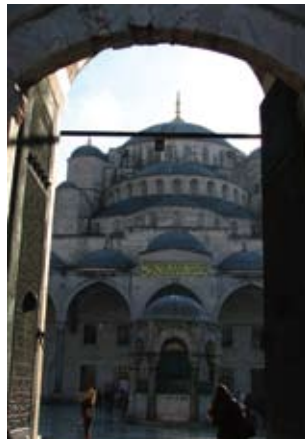
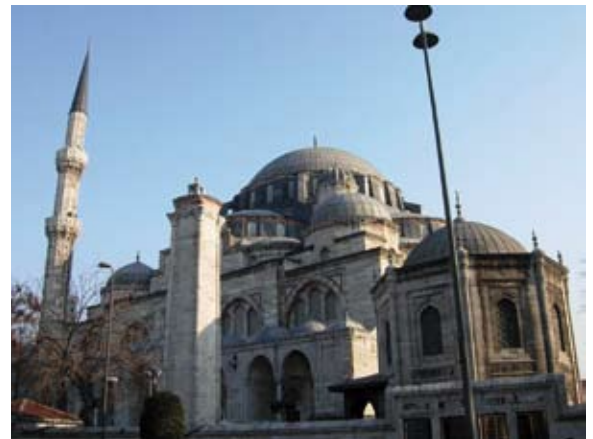
Figure 7. The Blue Mosque (or Sultan Ahmet Mosque) was built between 1609 and 1616 (left) and Şehzade Mosque built in 1548, both have been built with Limestone in İstanbul.

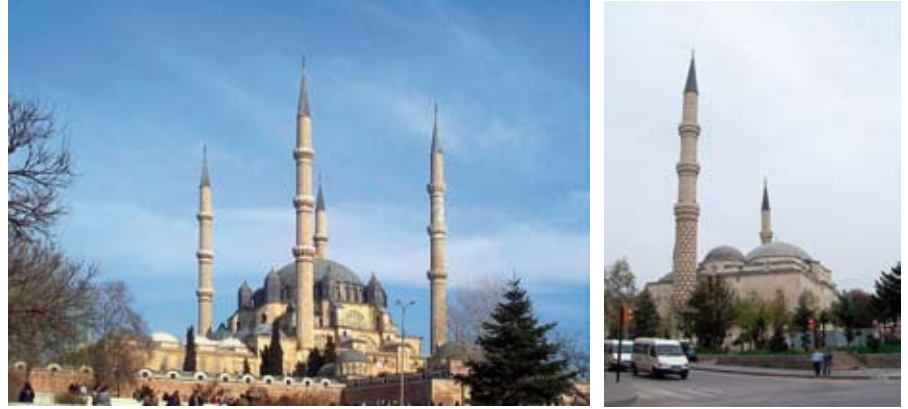
Figure 9. The ottoman Selimiye Mosque of Edirne (left) is one of numerous impressive Islamic buildings constructed from Limestone was built by architect Mimar Sinan between 1568 and 1574 and the Üç Serefeli Mosque, named after its unusual minaret with three balconies (serefe), was built between 1437 and 1447.

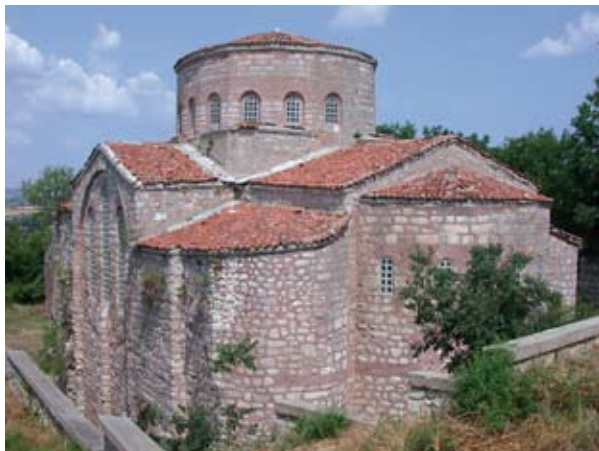
Figure 10. In the Small Hagia Sophia Church in Kırklareli stone damage was observed, which may superpose the heterogeneous distribution of different limestone varieties in the walls (at left, before turned into a mosque).

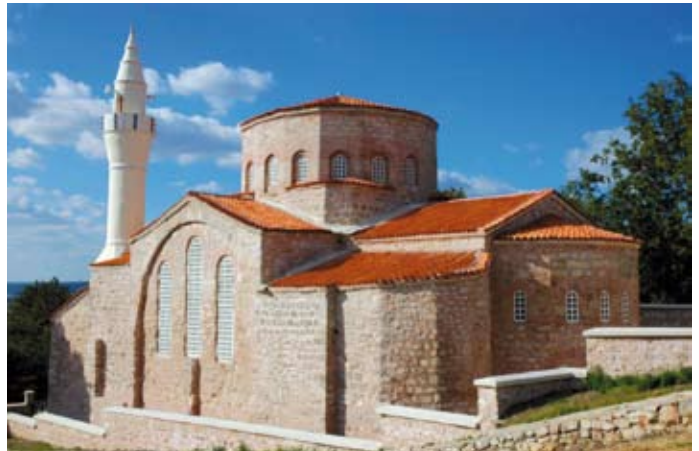
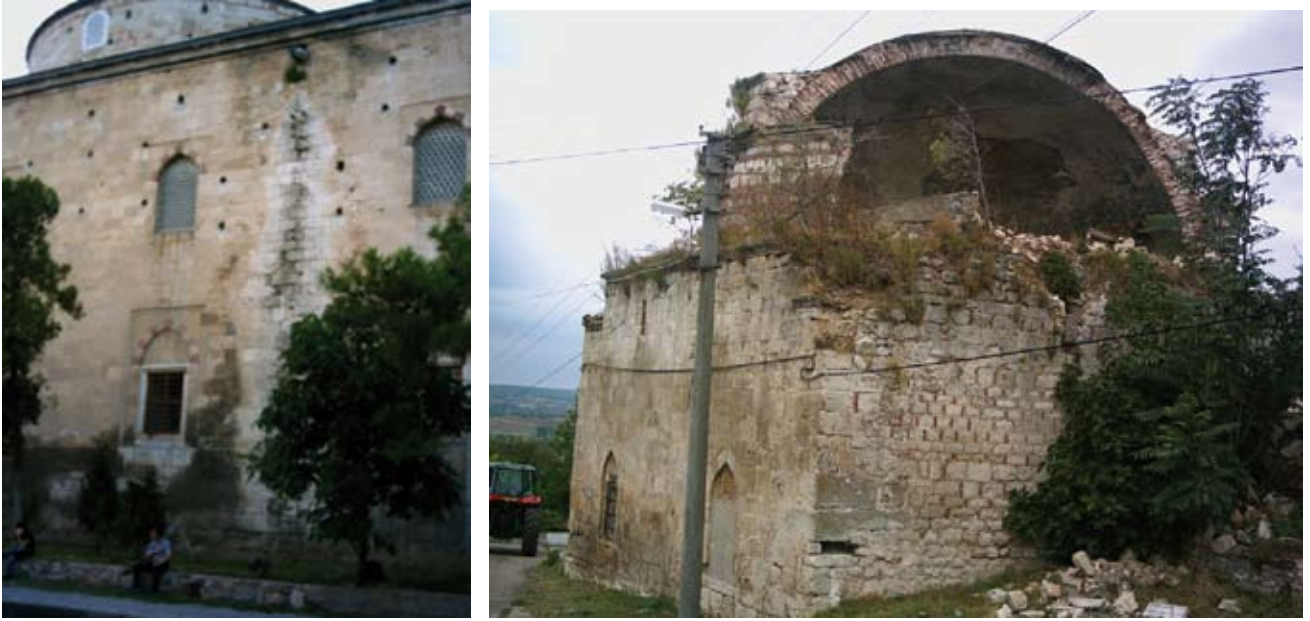
Figure 11. Eski Camii (Old Mosque) in Edirne was built of good quality limestone, but is being deteriorated by pollutants, sulfuric acid and carbon from domestic furnaces, which have combined with acid precipitation from long-range sources (left) and Şerbetdar Hasan Bey (Paşa) Camii at Vize province (Dal 2008).

parameters (7), wind parameters (8) and the pollution parameters (9). Air pollution has been widely documented as the main factor responsible for decay of building stones in urban areas. High levels of SO_2 in the polluted atmosphere conduct to the well-known sulphation mechanisms in a variety of lithological types used as buildings materials such as granite, sandstone and limestone. Biological colonization by bacteria, algae, fungi and lichens is frequently regarded as playing a significant role in physical and chemical stone decay only in rural, unpolluted areas (**Figure 11**).

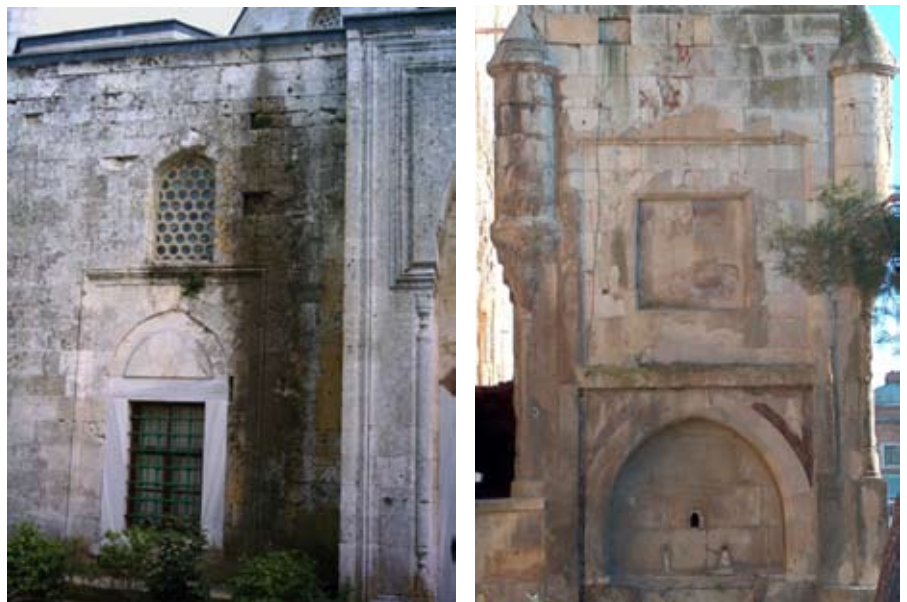
Figure 12. Acid precipitation attack the surface of the limestone and the reaction products run down the façade of II. Bayazıt Külliyesi (left) (Dal, 2005) and detail of the minaret of Old Mosque from Edirne: flaking and delamination are visible which cause material loss.

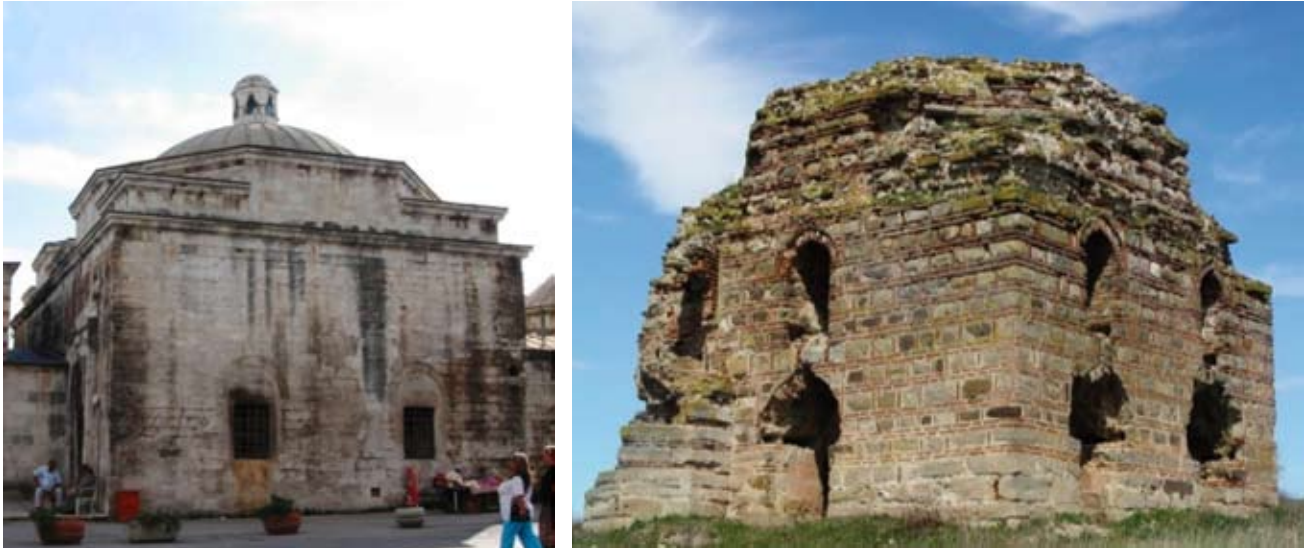
Figure 13. Accumulating black crusts at the north façade of Hızırbey Külliye from Kırklareli (left) and Gazi Turhan Bey Külliye Uzunköprü province in Edirne.
