Investigation of Architecture and Structural Deterioration Factors of Historical Kutahya Houses

Abstract

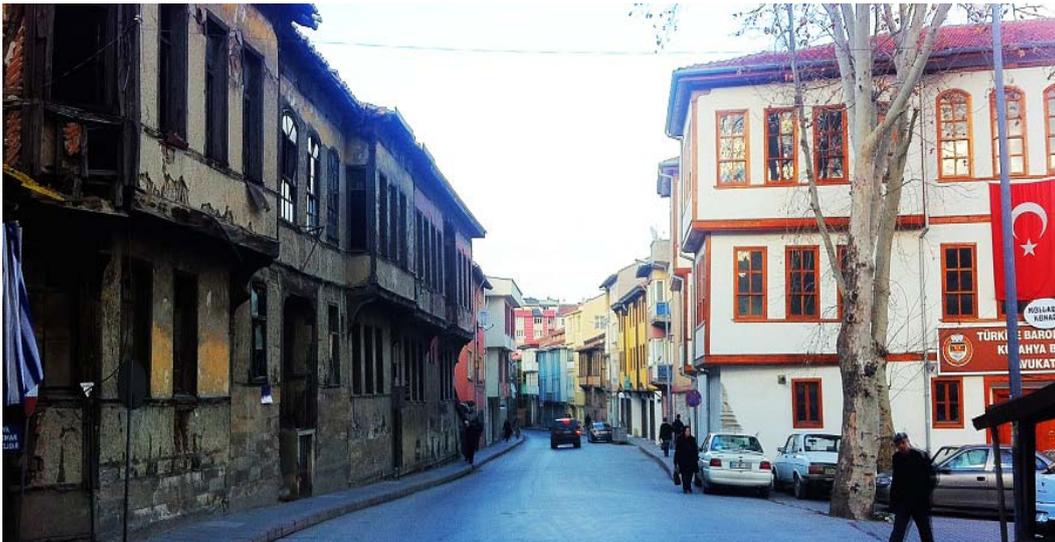
Figure 1. Street structure and the location of houses (writer archive, 2014)

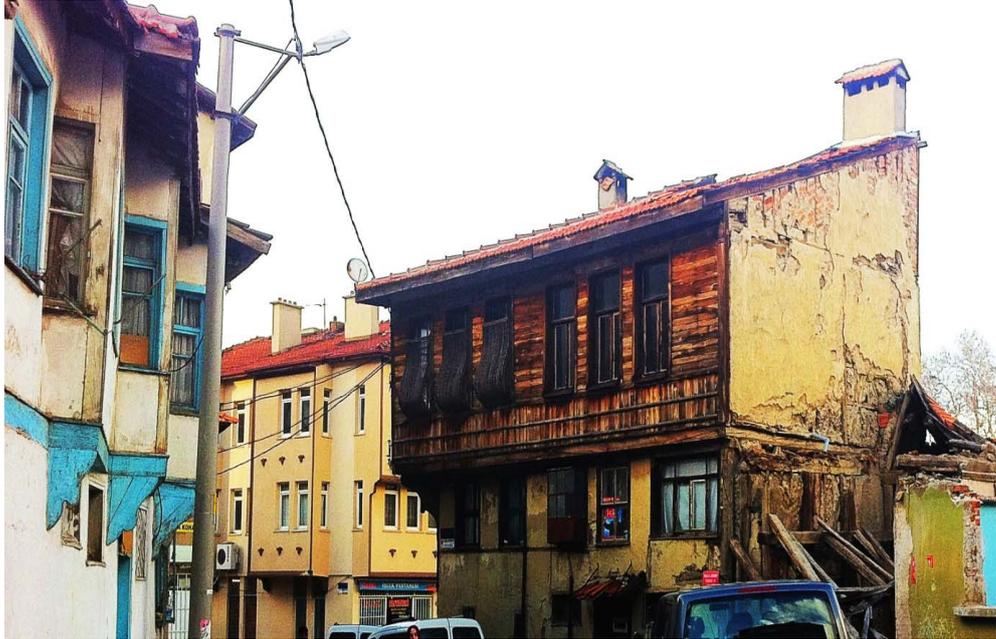
Wooden buttress outbuildings are the most important parts of Kutahya's houses. They are gradually in three floors and represent the desire to be outside. They are also convenient for perception of streets as vertical. In 19th and 20th centuries in which people preferred middle or inner sofa style, they used mostly window frame, eave, framing and bay window buttress for outside decoration more than inner one [2].

Figure 2. Buttress and outbuildings wooden houses (writer archive,2014)

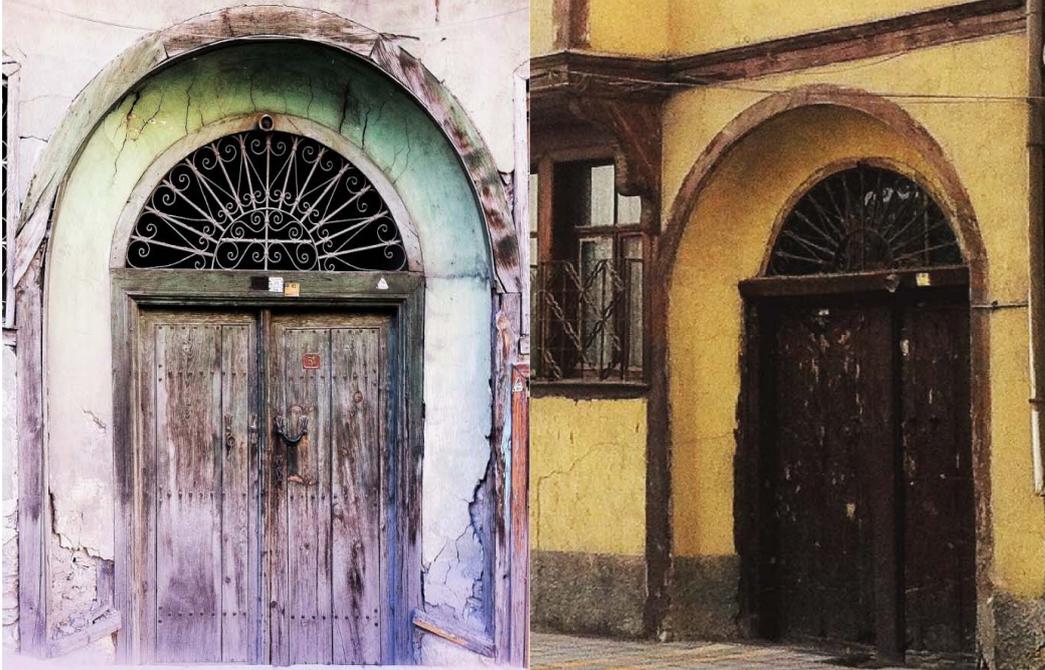
Figure 3. Double-leaf wooden and arched doors (writer's archive,2014)

Doors enable people to come in and be protected from outside. Windows are eyes of houses, and doors are like a mouth that is opened to outside for friends and stop enemies. People can come into houses mostly by using a street door and crossing the garden. House street doors are only decoration of buildings. Doors are usually double-leaf. They are on a wall reinforced with bonding timber, plastered with adobe, whitewashed, covered mostly with adobe and some stone. The duty of arc is not just to determine hinge and also to provide a basis for tri-serial drop nails. It prevents wings from changing shape. Interior doors are single-leaf doors. The duty of door wings is to save doorway. They are usually small. Most doors are opened to bottom of terrace. They all have sill. When the door wing is opened, it is provided that door is opened to area left inside of wardrobe width because people wanted inside of rooms not to be seen. There are mirrors and interlaced doors in Kutahya's houses. Even though there is much care and effort on the life's side, they have a rough appearance on the interior sides [2].

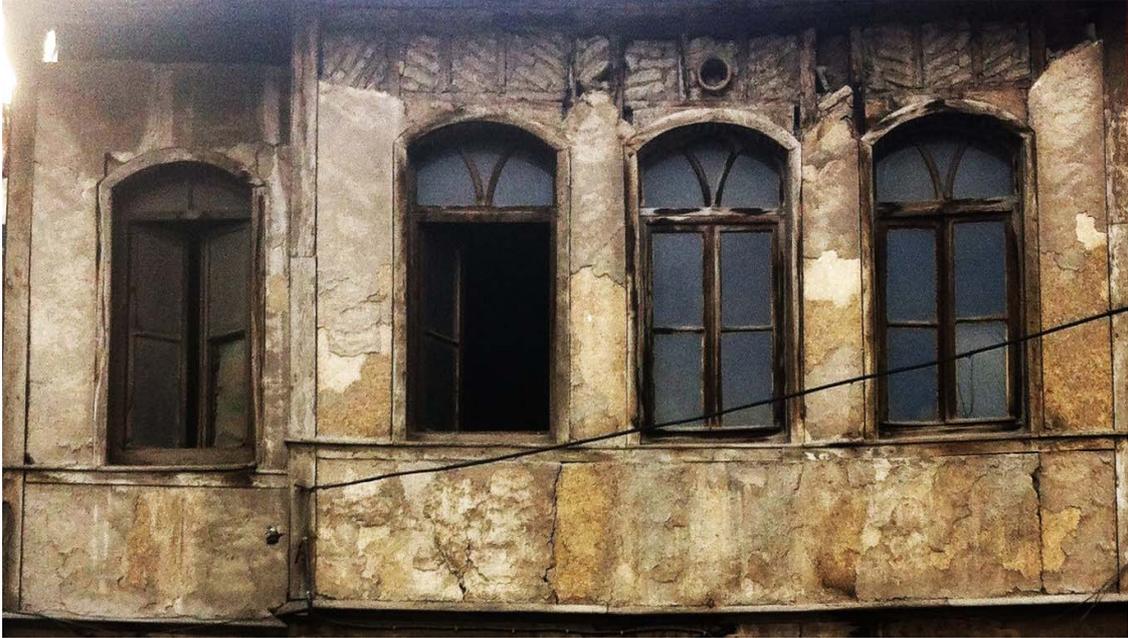
It is important that windows can be opened in several directions in empty rooms. Therefore, room is airy and gets sunlight, has a good fine view. Windows in the rooms are sorted in according to certain gaps. They are thin and long. There are frequent intervals between them. Since glass was very expensive in that time, windows were divided to 2-4-8 sections. People could use small pieces of glass when windows were broken [2].

Figure 4. Sectional windows (writer's archive, 2014)

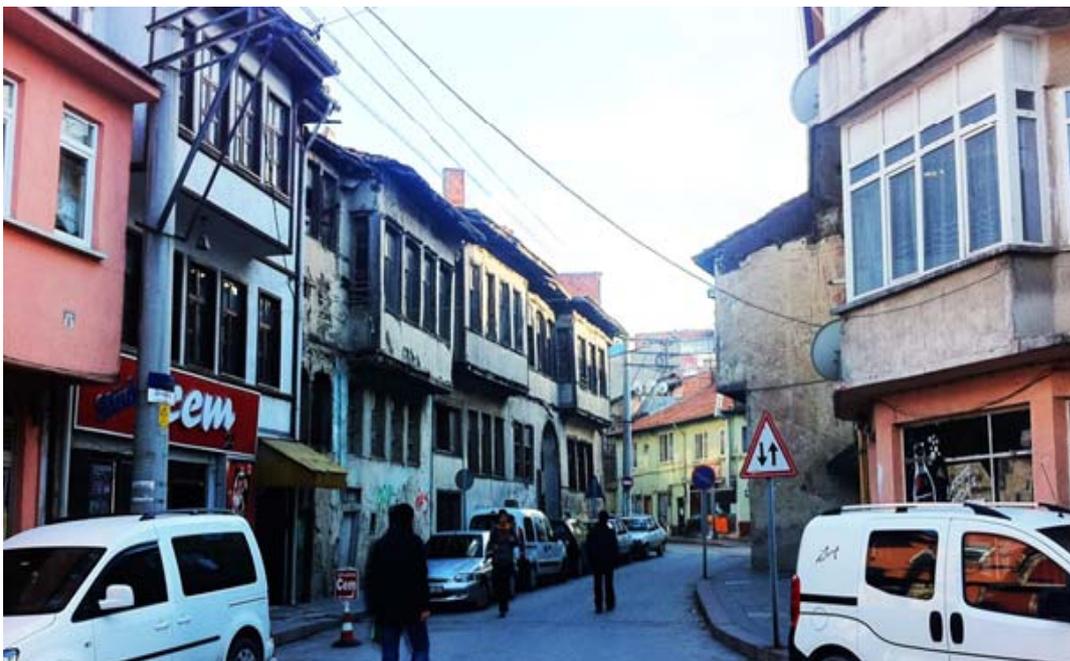
Row housing on both sides of the Street, the way that bay windows do not obscure each other and do not disturb other residences' windows enable neighbourhood relations to come to an agreement. The merits of respect, cooperation and love of neighbourhood relations play an important role in the shape of the street. Generally, the ground floor of the house but on the upper floors they go beyond their houses with the bay windows that provide them with a larger sight. Sometimes, eaves are about to touch each other but still do not prevent the sight of houses from the layout of row housing. The streets, narrowing and enlarging from place to place, creating fountain gatherings at the corners and giving rise to surprises with sudden chops and changes are the product of good and happy neighbourhood relations.

Figure 5. Row housing with bay windows (Author achieve, 2014).

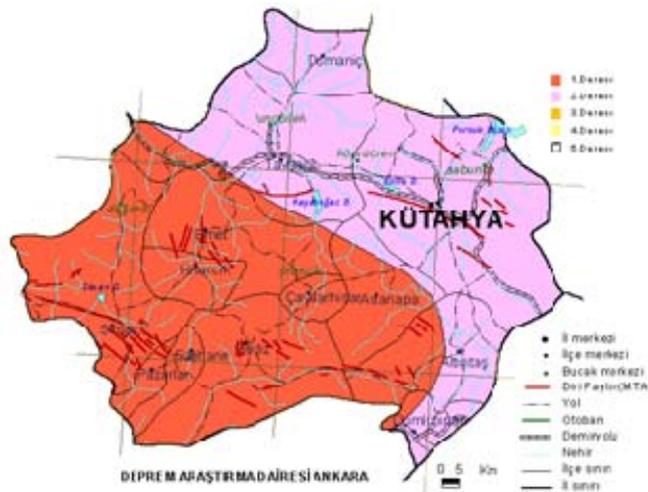
Figure 6 .Kutahya regional earthquake map, Republic of Turkey Prime Ministry Disaster and Emergency Management Presidency Directorate General of Earthquake [4].

This map was prepared with the help of present information and entered into enforce in accordance with the decision of the Council of Ministers dated 18th April, 1996 and numbered 96/8109. Different from the previous maps, earthquake zones were

determined on the basis of contour map which is drawn according to the probability calculus. According to this, it is estimated that a normal structure, with 90% probability, will not be exposed to a more loading than these acceleration values in its 50 year economic life. For important structures or the structures with longer economic life, the highest acceleration values that they may encounter need to be calculated.
